# Geologic Report on the 1993 Bliss Landslide, Gooding County, Idaho

Virginia S. Gillerman

Staff Report 01-1  
December 2001

Idaho Geological Survey  
Morrill Hall, Third Floor  
University of Idaho  
Moscow, Idaho 83844-3014

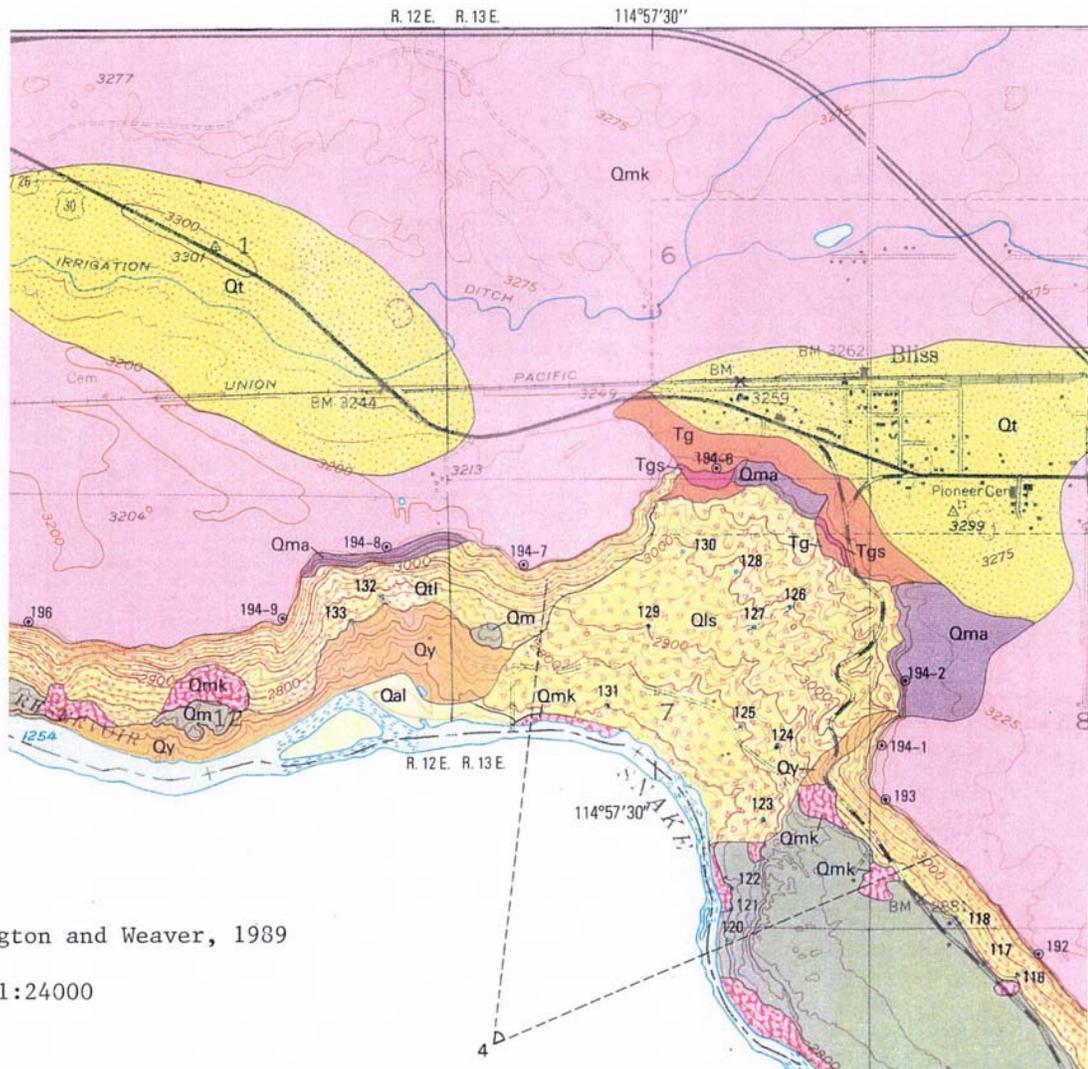
FIGURE 2  
 Covington and Weaver, 1989  
 1:24000

The Bliss landslide is a reactivation of an old Quaternary landslide zone (Qls in Figure 2) which covers most of the Bliss alcove located southwest of town. A second landslide, which a local resident said formed in the 1930's, is located across the river south of the present slide. The Bliss alcove is at a prominent bend in the river, downstream from a long straight segment. Unfortunately this helps focus the power of the Snake River on the toe of the slide. The linear river reach suggests the possibility of regional northwest-trending faults or joints cutting the Tertiary units. A major topographic alcove and three canyons filled with Madson Basalt could also be interpreted as supporting evidence for hidden NW and NNE-trending structures that fractured the Tertiary rocks.

Figure 2. Geologic map of Bliss area from Covington and Weaver

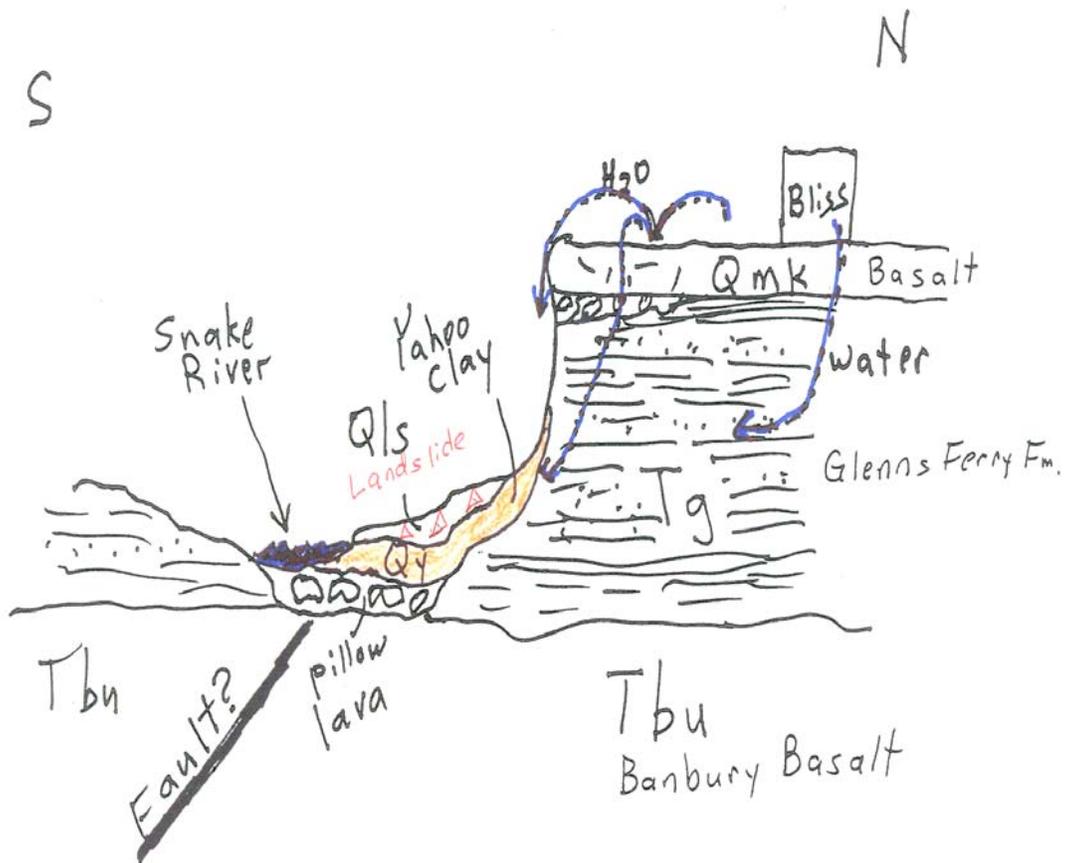
Wet clays swell and become very slippery. The interbedded clays and silts of the Glenns Ferry Formation are notorious for hosting numerous landslide deposits all along the Snake River Canyon. Fractured basalt rimrock, porous pillow basalts, sandy layers of the Glenns Ferry, and bedded porous basalt cinders are sufficiently permeable to transport surface and groundwater into the Glenns Ferry Formation. In addition, the Yahoo Clay acts as a confining unit, creating a barrier to groundwater movement out of the canyon walls (Covington and Weaver, 1989). This creates a confined aquifer condition that can produce excess water pressures in the Glenns Ferry sediments below the Yahoo Clay or clay-rich Quaternary landslides (Figure 2b).

Figure 2b: Schematic cross-section of canyon at Bliss, showing geology and hydrogeology.

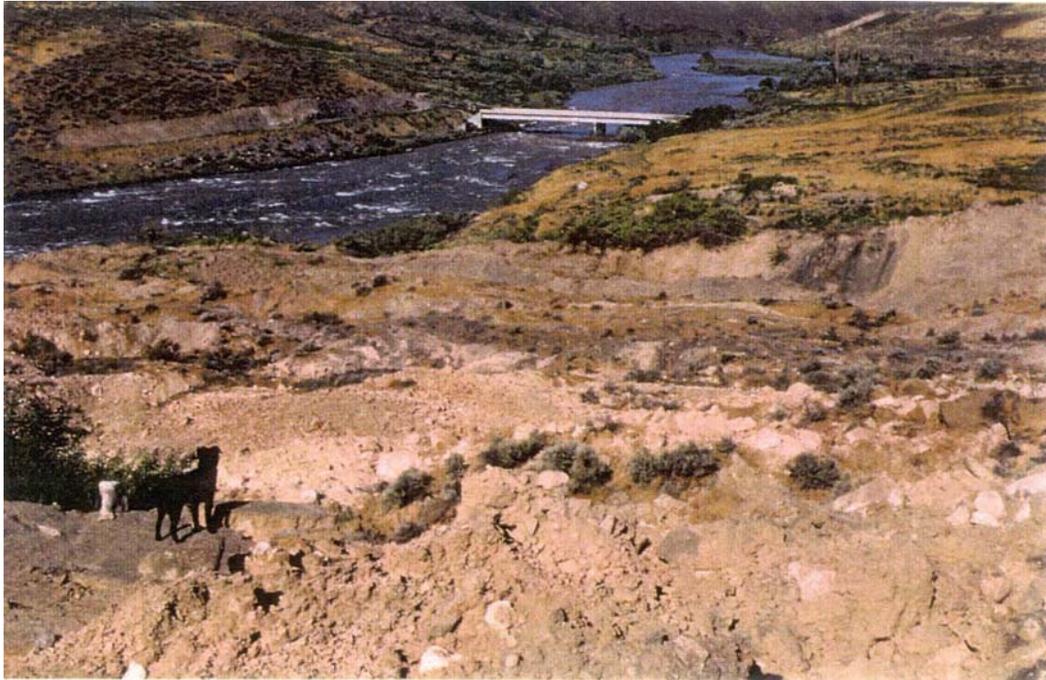
Figure 3a. Bliss landslide, looking southwest from end of asphalt road, July 27, 1993.

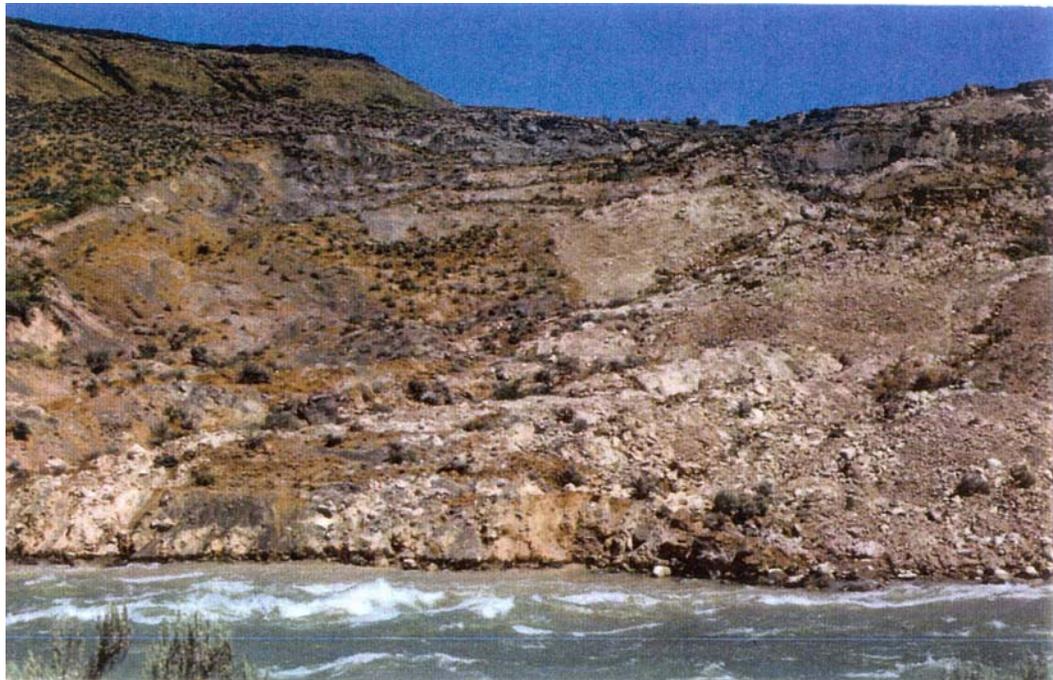
Figure 3b. Bliss landslide, looking north from south bank, Snake River, July 27, 1993.

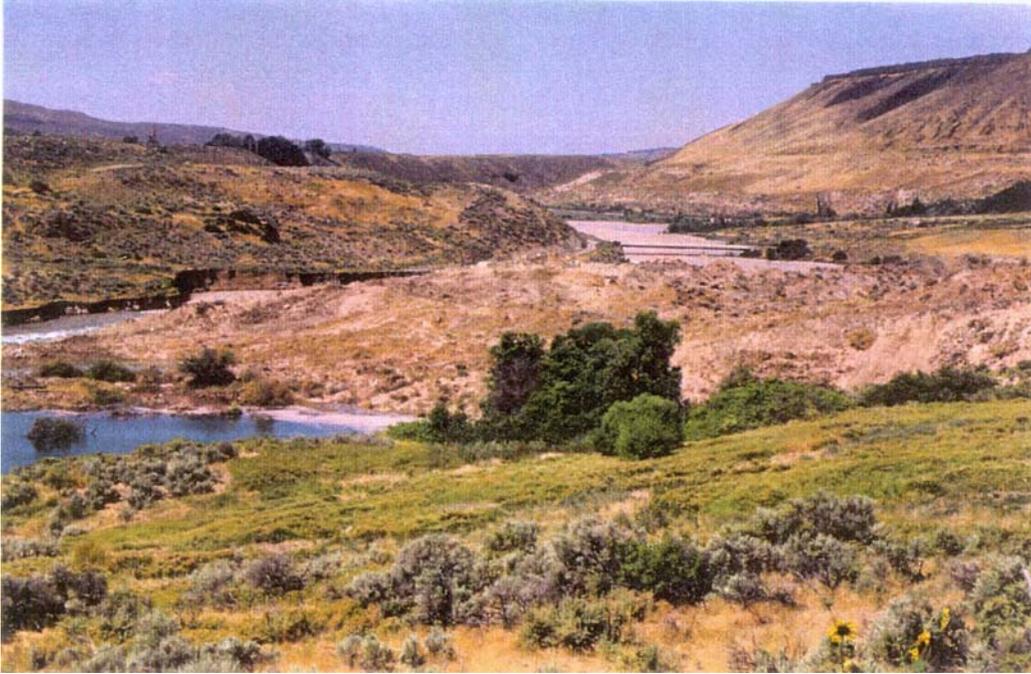
The river channel through the toe of the slide appears to have stabilized some between the August 6 and August 12 visits, judging from the color of the river water. However, erosion of material from the toe of the slide into the river will continue. As support material is removed from the bottom of the slide, it will continue to grow headward. As of August 12 it appeared that most new fractures were above the northwest part of the slide, closer to the modified Sheep Trail (the original one cracked off over two weeks ago) than to Highway 30. The center portion of the slide “blowout” appeared to have deflated and tilted northward in a series of rotational slumps. This creates a flatter, more stable slope gradient below a steeper part still headward. More recent information says that this steeper part is the site of new large cracks (J. Garth, personal communication).

Figure 4a. Bliss landslide, looking southwest at toe of slide in river, August 6, 1993.

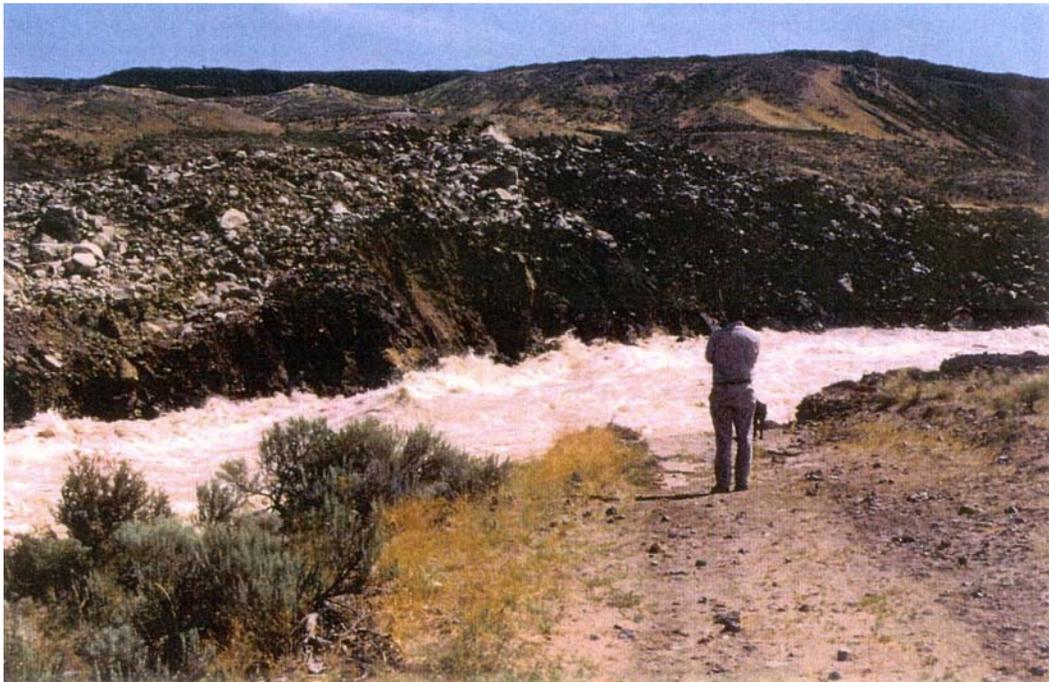
Figure 4b. Bliss landslide, looking north at toe from south bank. Pillow lava outcrop to right of person, August 6, 1993.

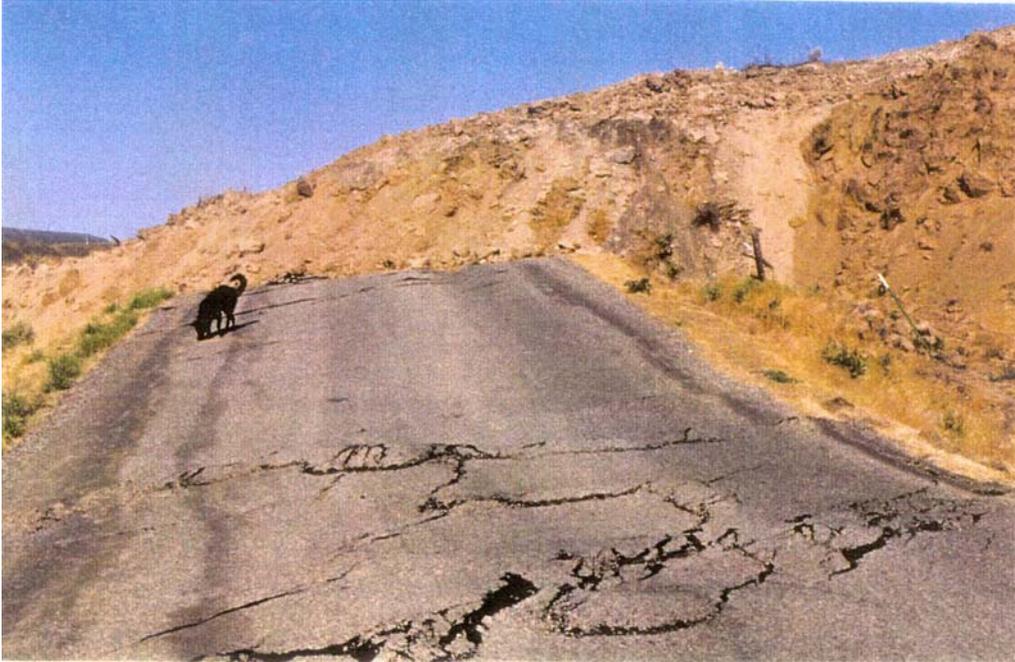
Figure 4c. Bliss landslide, from end of asphalt road, looking west, August 6, 1993.

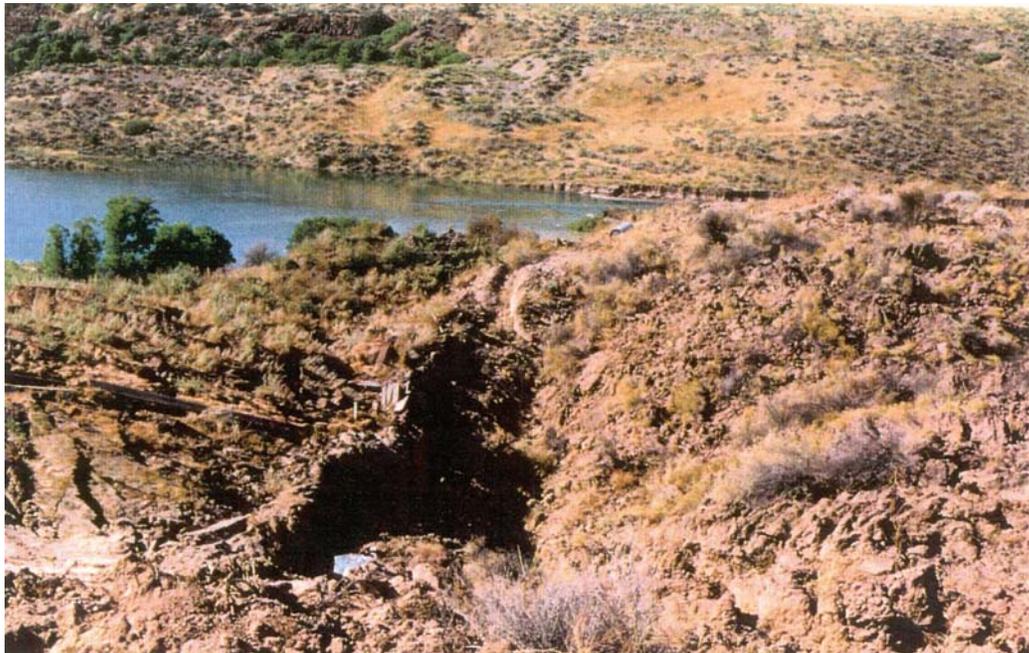
Figure 4d. Bliss landslide, looking south at east margin of slide, August 6, 1993.

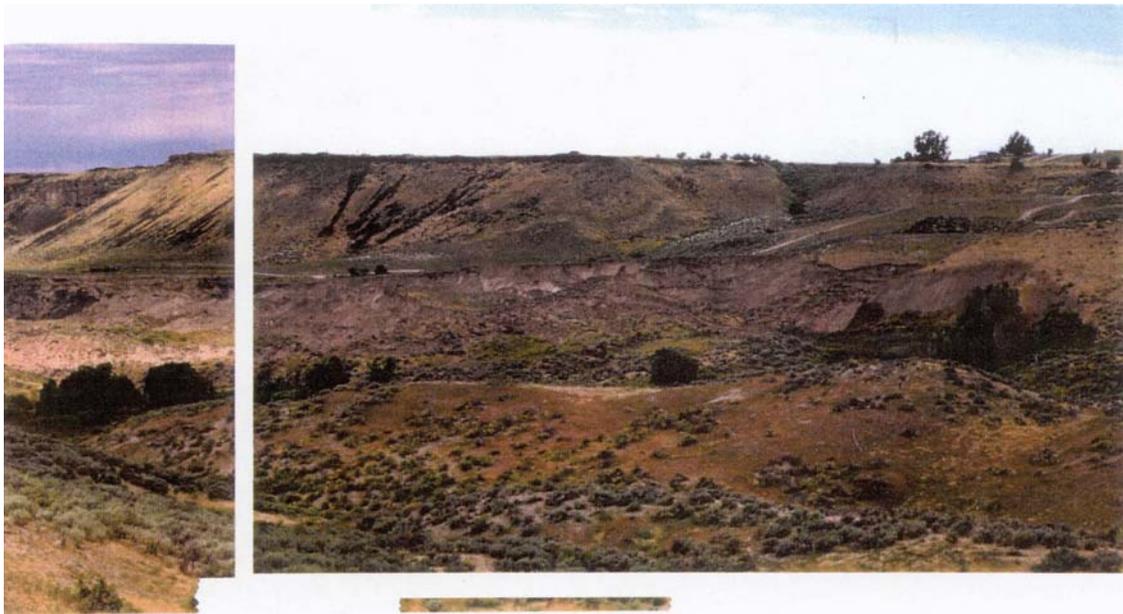
Figure 5a. Upper portion of Bliss landslide, panorama, looking west from old Highway 30, August 12, 1993. Note multiple rotated blocks and old scarps

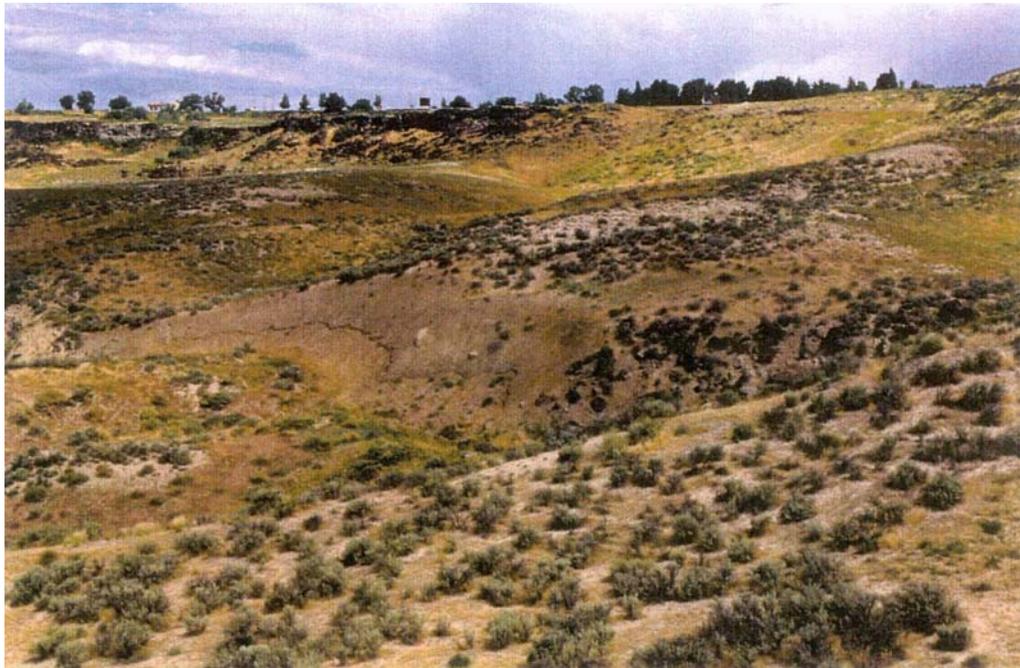
New offsets of a few inches are now noticeable on past, unvegetated landslide scarps (Fig. 5b, 5c) within a few hundred feet of old Highway 30 which crosses two major old scarps. At the uppermost scarp, the steep highway surface has been patched repeatedly and cracks cut the most recent generation of asphalt.

Figure 5b. Bliss alcove, old scarp with 3 inches of new offset, looking northwest, August 12, 1993.

4. Monitor with survey stakes and instrumentation the cracks and old scarps along old Highway 30 south along the Bliss grade from about 3,200 feet elevation to the bottom at 2,900 feet elevation. Particularly dangerous is the upper landslide scarp at about 3,070 to 3,100 feet elevation, just up from the big pullout where all the sightseers park. Monitoring should be done at least three times a week and the road closed if an increase in movement rate or cracking is noted.

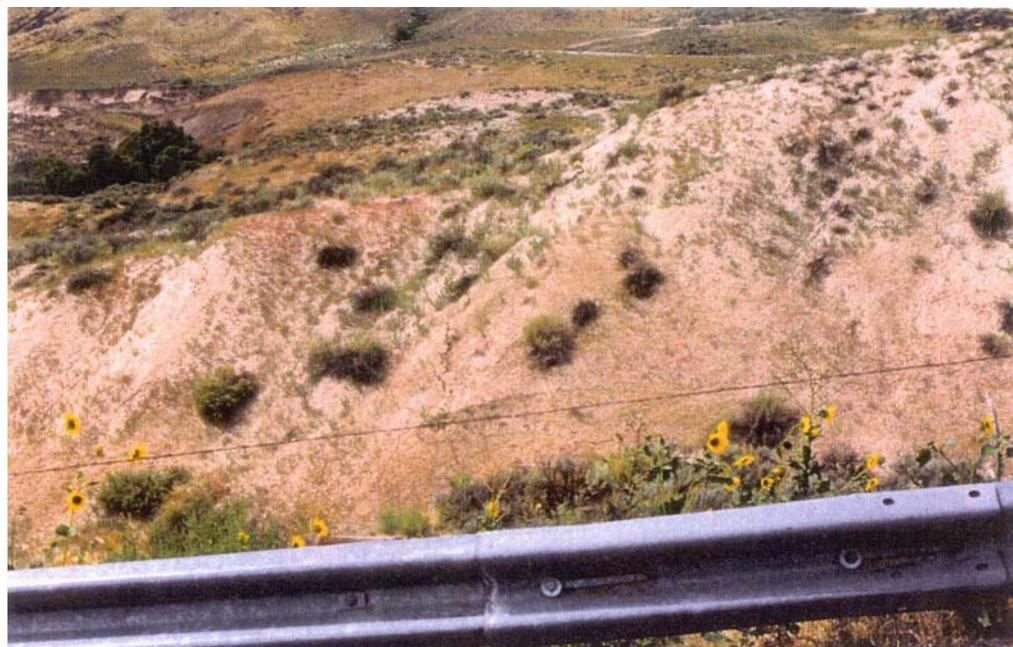
Figure 5c. Bliss alcove, closest new break to old Highway 30. Less than 4 inches displacement, looking northwest, August 12, 1993.

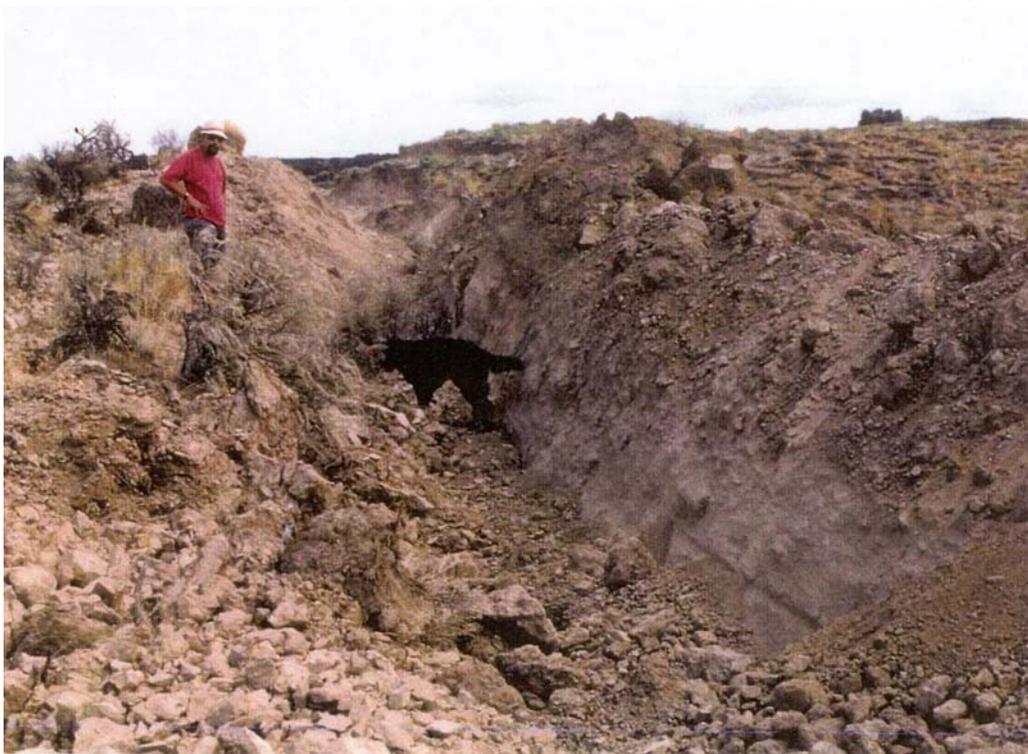
Figure 5d. Bliss landslide, fault surface on east margin of slide. Extends approximately 800 feet August 12, 1993.

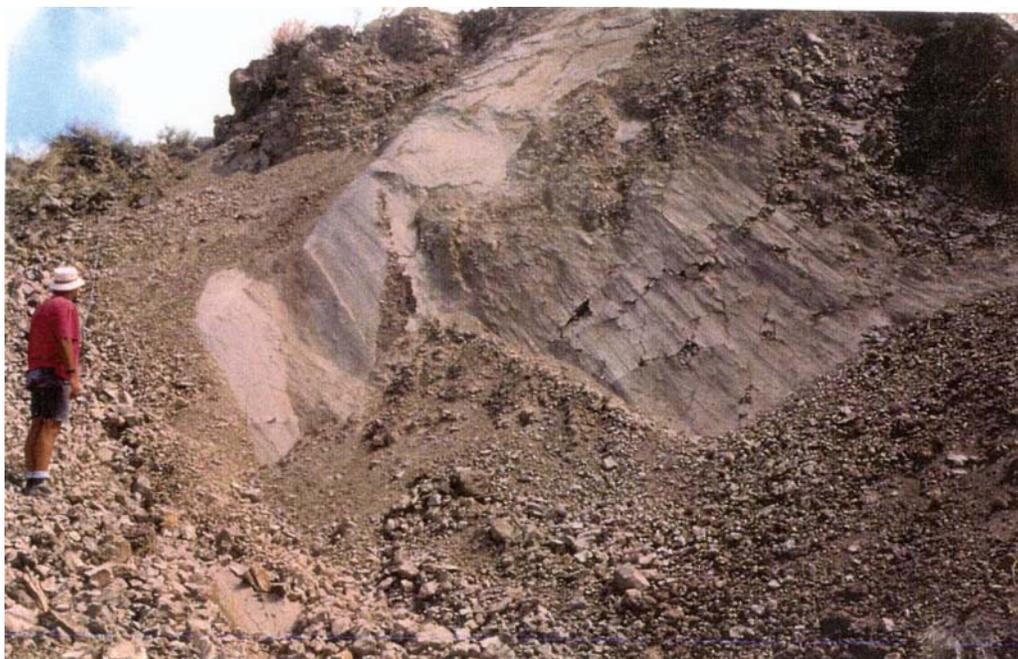
Figure 5e. Bliss landslide, strike slip merging into dip-slip fault surface. East margin of landslide, August 12, 1993.
