Ground-Water Interactions Near the Highway Pond Gravel Pit, Pocatello, Idaho

John A. Welhan

Staff Report 01-3
January 2001

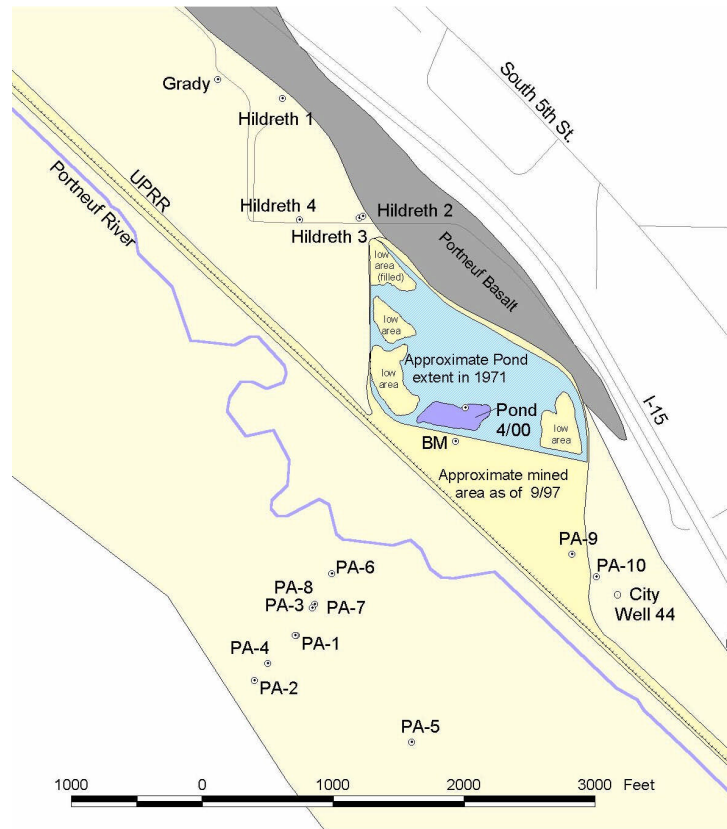
Figure 3 shows salient features in the study area, including monitoring wells for which historic water table information is available, the locations of private wells surveyed in this study, and Pocatello Municipal Well 44. Table 2 summarizes the survey and water level data. The area of the ITD gravel pit is approximated by the areal extent of the Highway Pond shown on topographic maps (U.S. Geological Survey, 1974). The dark area within the pit is the currently exposed area of the water table; other irregular areas within the pit are low-lying areas that have been chronically submerged in the past six years, including the back-filled low area in the north corner of the pit.

Figure 3. Study area showing relevant features. The area in blue represents the approximate extent of the gravel pit under totally submerged conditions shown in 1974 U.S. Geological Survey topographic map. Extent of mined area is from the geologic map of Othberg and Rodgers (1999). Dark area in gravel pit is exposed water as of May, 1999. Low-lying areas and area of back-filled gravel are also shown. PA-series wells are monitoring wells installed by CH²M-Hill (1995). Location of the cross-section shown in Figure 2 is along the line of wells from PA-2 to PA-6 extended across the valley to the gravel pit, with well PA-9 projected into the plane of the section.

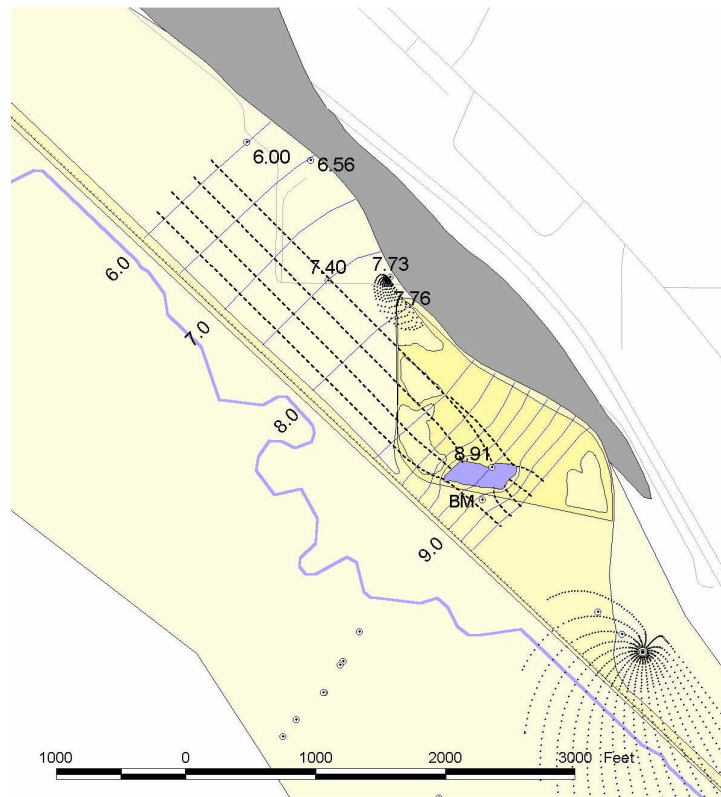
Figure 4. Representation of the ground-water flow field at low water table elevations (May, 2000), into and out of the Pond, together with predicted impacts of pumping wells. Water table elevation contours are shown labeled as feet above 4400 foot datum, with a variable contour interval to show effects near the Pond. Ground-water flow paths into and out of the Pond are shown as dashed lines. One-year capture zone shown for continuous pumping at Pocatello Well 44; six-month capture zone shown for Hildreth irrigation Well 3. Dotted lines indicate ground-water flow paths converging on the pumping wells.

The flow net shown in Figure 4 expresses the relationship between water table elevation and inferred ground-water flow direction arising from that water table configuration. Solid lines extending southwestward from the basalt are contours of equal water table elevation; dashed lines represent ground-water flow moving into and emanating from the Pond. Note that the flow net shown upgradient of the Pond is unconstrained because of the lack of measurements and the influence of Well 44.

The flow net analysis provides a visual approximation of the areas of the aquifer affected by infiltration of water from the Highway Pond. Currently, the area of impact is limited to the area directly downgradient of the exposed Pond. Thus, under such conditions, Hildreth Well 2 is not in the Pond's area of impact unless locally induced water table gradients distorted the flow lines shown in Figure 4.

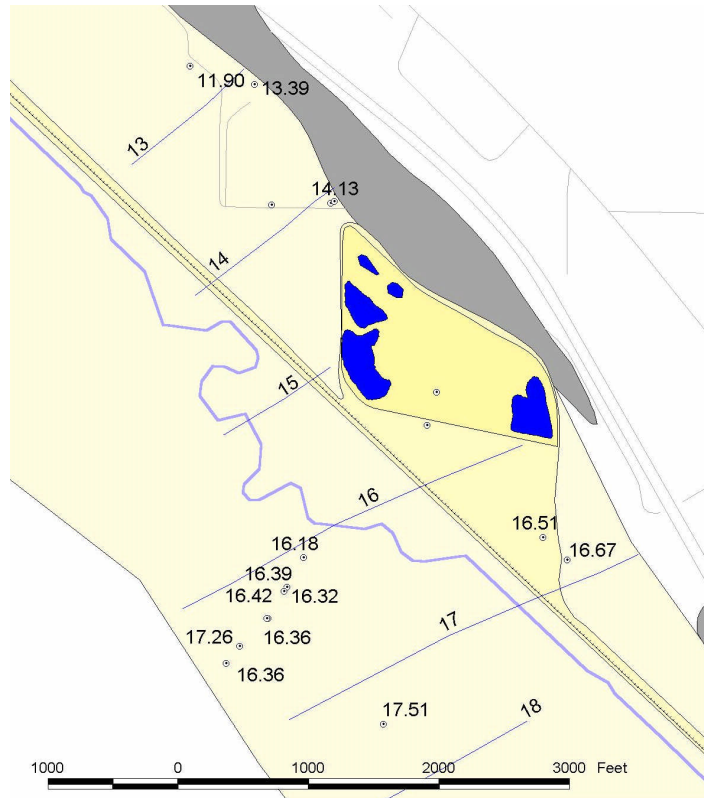
Figure 5 summarizes water level data measured in a number of wells in the study area on May 12, 1994 (CH²M-Hill, 1995) prior to the installation of Pocatello Municipal Well 44. Water levels are shown relative to the 4440 ft datum. Contours of the water table indicate a general ground-water flow direction that is parallel to the valley axis and the aquifer's boundaries. This is consistent with historic water level records dating back to

Figure 5. Water table elevations in wells relative to 4400 foot datum, as measured May 12, 1994 (CH²M-Hill, 1995). Contours have been simplified to reflect a hydraulic gradient that is predominantly along the axis of the valley. Dark blue areas in gravel pit represent approximate extent of areas submerged in 1994 (see photo D, Appendix I).

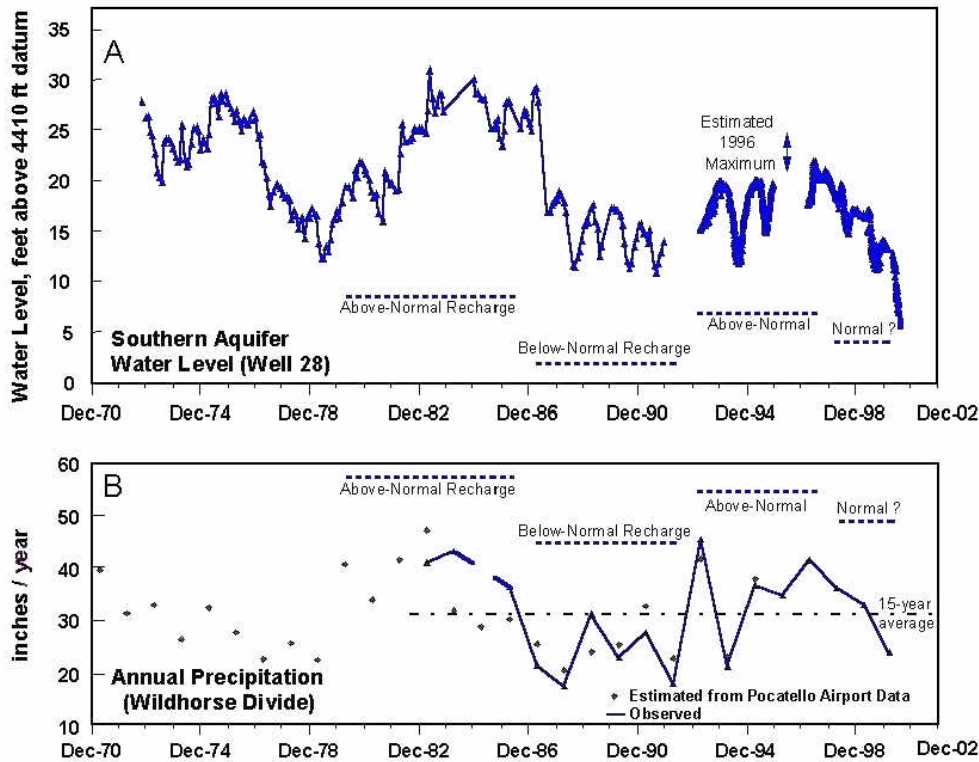
Figure 6 summarizes the water level record at Well 28 (measured when the well was not pumping), together with total annual precipitation recorded at the National Research and Conservation Service's SnoTel station on Wildhorse Divide in the Bannock Range, the aquifer's principal recharge area (Welhan et al., 1996). Well 28's response over three decades shows a consistent pattern of (a) pumping-induced drawdowns of the order of 1-2 feet at pump rates of 800-1200 gallons per minute, (b) a general summertime pumping period decline of the order of 5-10 feet, followed by (c) a post-pumping period of recovery and a variable amount of spring recharge-induced water level increase, and (d) a suggestion of a secular correlation between total precipitation (maximum available recharge) and aquifer water level. It is apparent that static water levels in the Ross Park

Figure 6. (A) Water levels in Municipal Well 28. (B) Total annual precipitation measured at Wildhorse Divide SnoTel station in the aquifer's principal recharge source area. No water level data are available for 1996 due to data logger battery failure; an approximate maximum range was estimated from a contemporaneous rise at the Highway Pond (compare photos for 1994 and 1996 in Appendix I).

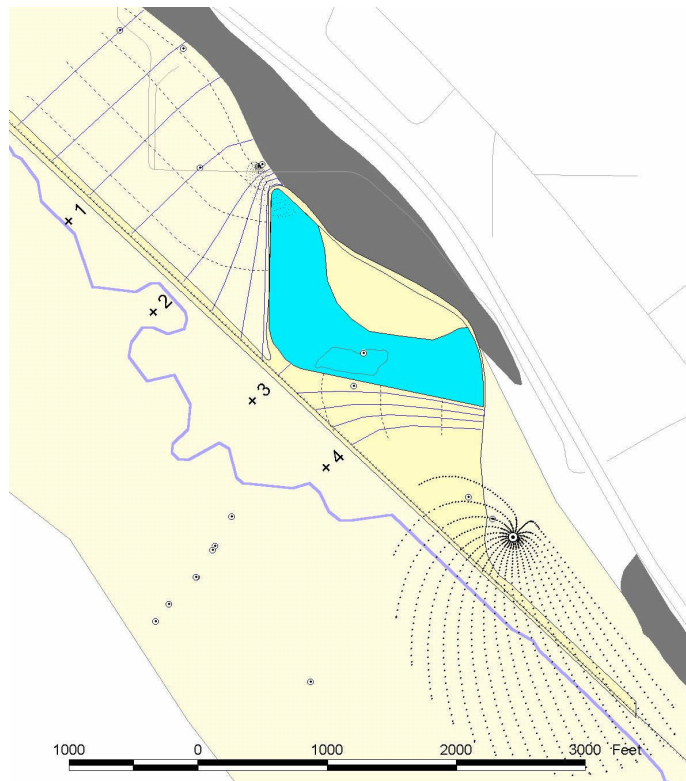
Figure 7 shows the approximate extent of the area submerged under moderate- to high-water table conditions. A larger area of the water table is exposed and the pattern of ground-water flow around the Pond is altered over a much larger area. Although this is an approximate representation of the ground-water flow net, constrained solely by the area of the exposed water table and previous assumptions, it represents the salient features of the ground-water flow field to be expected under these conditions. Note how the water table contours are warped immediately upgradient and downgradient of the Pond, thereby spreading water which seeps from the Pond over a much larger area of the aquifer (including areas west of the rail line). In comparison with the flow net of Figure 3, the

Figure 7. Representation of the ground-water flow field at moderately high water table approximating the 1996-97 level of the Pond (shown in blue; cf. Figure E in Appendix I). Well capture zones from Figure 3 are shown for reference. Water table elevations are shown as feet above 4400 datum, with a variable contour interval.

conclusion is inescapable that a larger pond surface area exposes a larger area of the aquifer to water that has resided in the Pond.

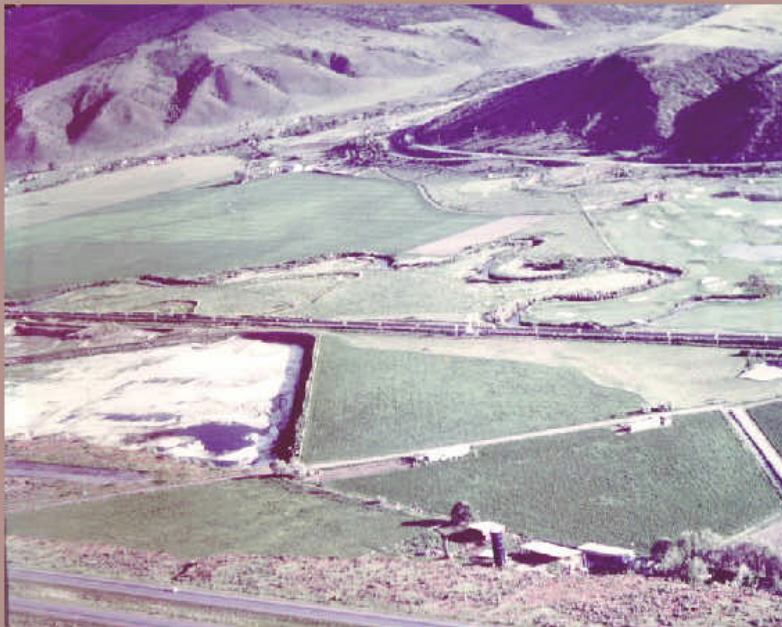
1982 or 83

A.
1982 or
1983
Source:
Keith
Hildreth

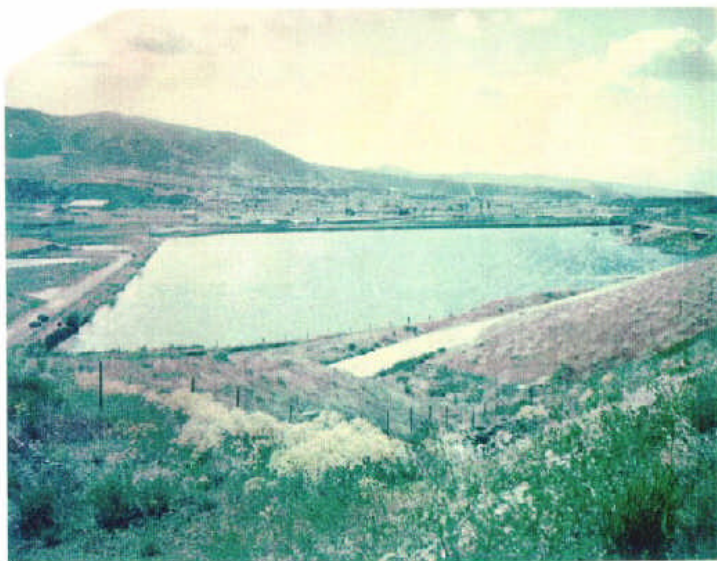
B.
Summer
1984
Source:
Bud
Hildreth

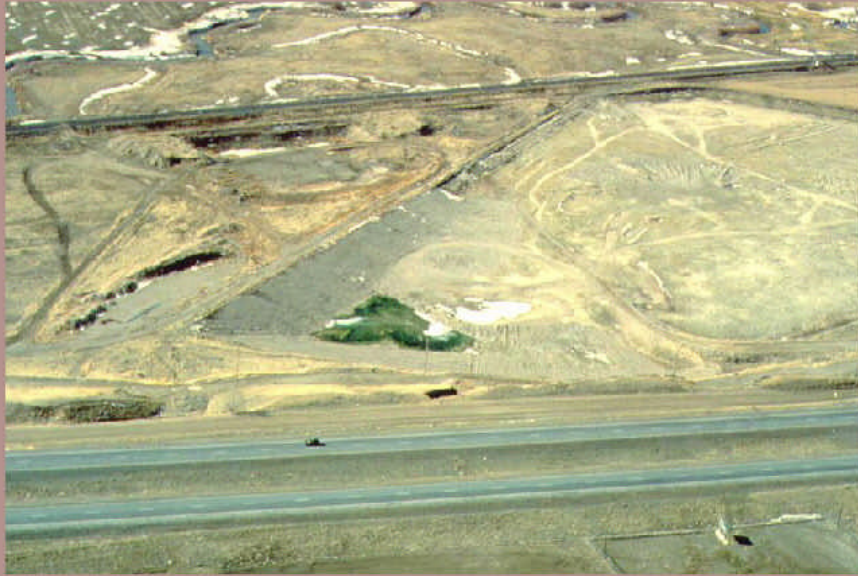
1992

C.
Winter
1991-92
Source:
Author

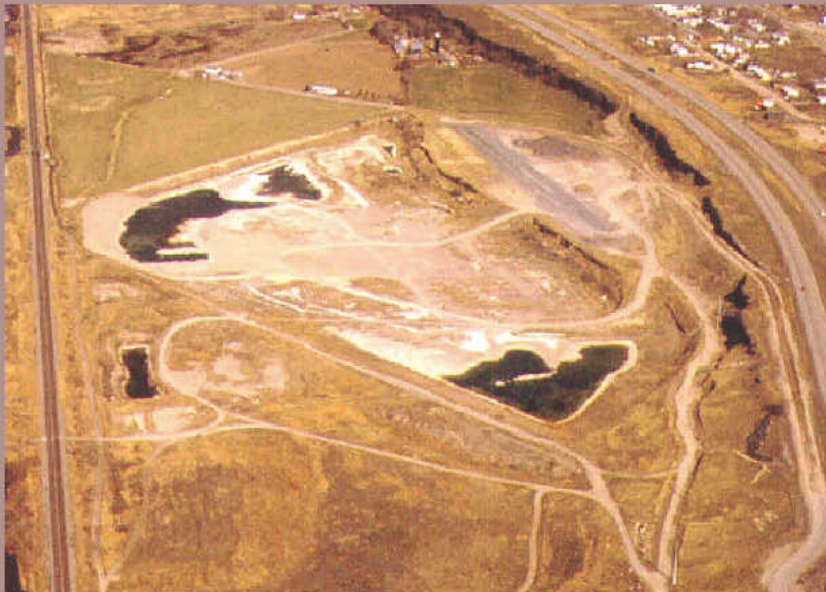
D.
Spring
1994
Source:
Author

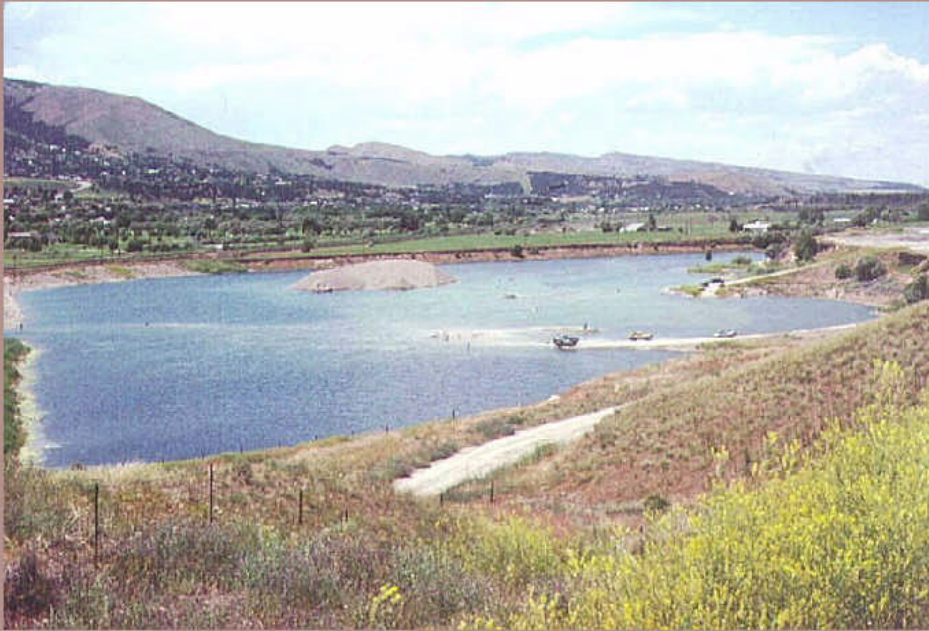
E.
Summer
1996
Source:
Author
