What are landslides?

W. Phillips, D. Garwood, and R. Stewart, 2008, Landslide Hazards of Idaho: Idaho Geological Survey GeoNote G-44.

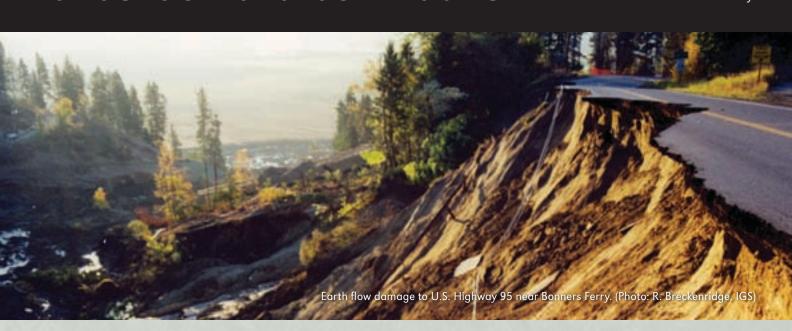
Transverse ridges Radial cracks Toe of surface of rupture Surface of separation

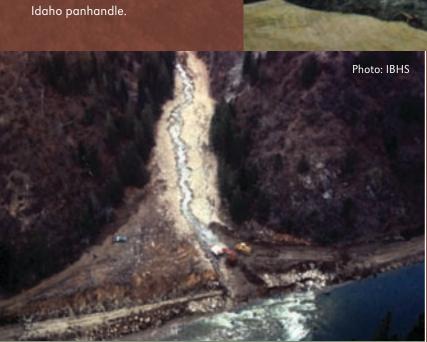
Debris flow damage to road caused by heavy winter precipitation on the Middle Fork Boise River near Atlanta.

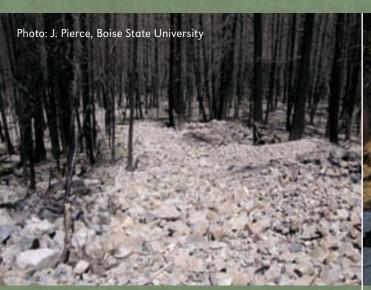
Debris flow deposits along Fourth of July Creek, near Stanley. The forest was burned by wildfire in the fall of 2006.

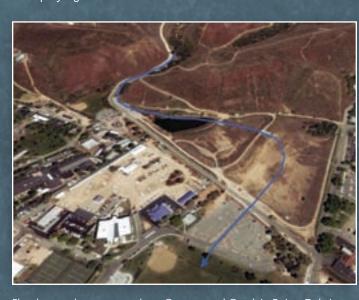
Flood control structures along Cottonwood Creek in Boise. Debris from Cottonwood Creek is routed into sediment retention pond and, if necessary, onto parking lot and playing fields.

mostly from deposits of sediment. On September 11, 1997, a cloudburst dropped 0.40 inch of rain in nine minutes in the same foothills burned by a 1996 wildfire. The resulting flood of mud and debris damaged several homes and an elementary school. Presently, Boise operates sediment control structures on the drainages that were involved in these events. The structures are designed to channel flood water and mud away from residential and business districts into holding ponds and onto playing fields.
